Testing high-voltage systems with thermal imagers from Testo.

Thermography increases reliability of supply

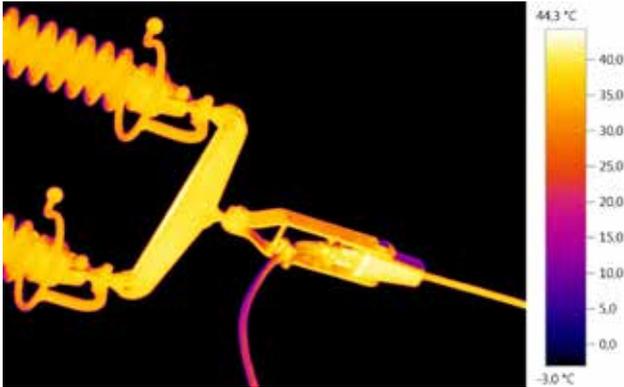
Checking the clamp connection on the isolator

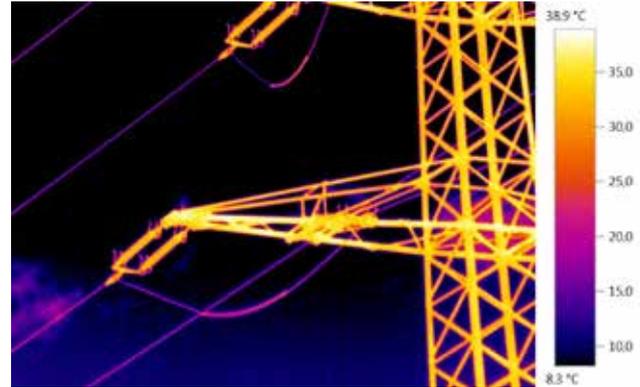
Thermal image of the current loop on a dead-end tower
