Practical guide Thermography for heating contractors.

How thermal imagers from Testo can help you to reduce costs and increase sales.

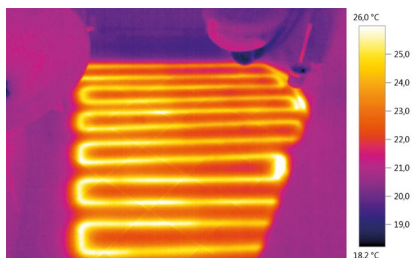
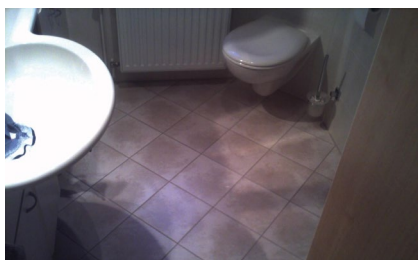
- The area to be examined is restricted to the relevant section.
- Thanks to the good visibility in the thermal image, the course of the pipework can be easily and conveniently traced (cf. adjacent illustration).

In order to locate a leak in the heating system pipework, the first task is to trace where the pipes run. The time for this can be considerably reduced by using a thermal imager from Testo:

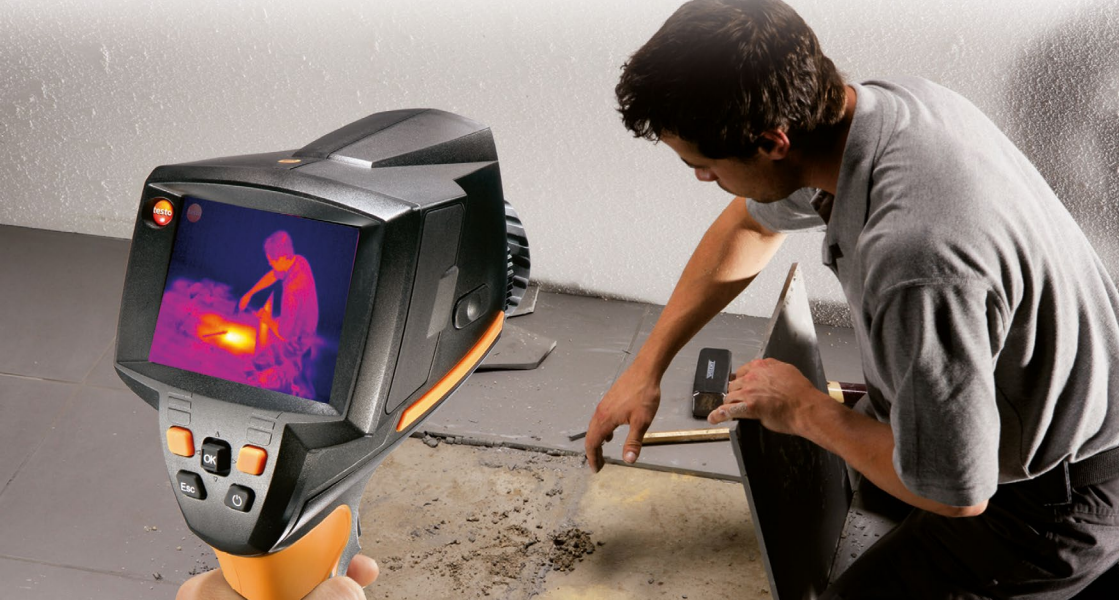
Once the thermal imager has established the pipework runs, efforts can be focused on locating the leak. The image on the right depicts the thermal survey of a glazed walkway between a lounge and kitchen extension. The homeowner is complaining of occasional water leakage under the tiled floor. The thermal image shows the heat pattern effect from the heating pipes running under the walkway. At one point they clearly exhibit increased temperature concentration. This hot spot indicates a possible leak from the central heating system. Leaks are usually identifiable by an irregular-shaped hot spot. With the help of thermal images, the possible location of the problem in the heating pipe could be detected.

Further examinations proved that there was in fact a leak at this location.

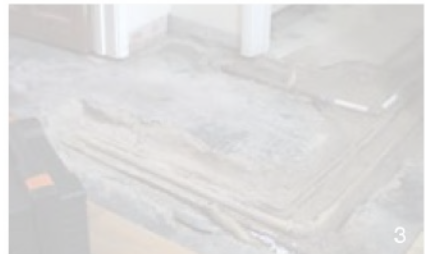
In diesem Fallbeispiel hatten klassische Methoden versagt, und Testo wurde gebeten, die Leckage mit einer Wärme- bildkamera nachzuweisen. Für diesen Einsatzbereich eignen sich am besten die Geräte testo 885, testo 886, testo 871, testo 872 und testo 876. So konnte der Leitungsverlauf über die freigelegten Bereiche hinaus erfasst werden. Innerhalb kurzer Zeit wurde
